**Flood Control Project Maintenance
Levee Inspections**

Maintenance Issue Types Only, Levee Inspection Report By Mile - Fall 2019

Sacramento River West Side Levee District

Waterway	Bank	Unit Miles	Inspection Start/End	Inspector
Unit No. 01 Sacramento River	Right	49.64	10/22/2019 10/22/2019	Zach Jojola

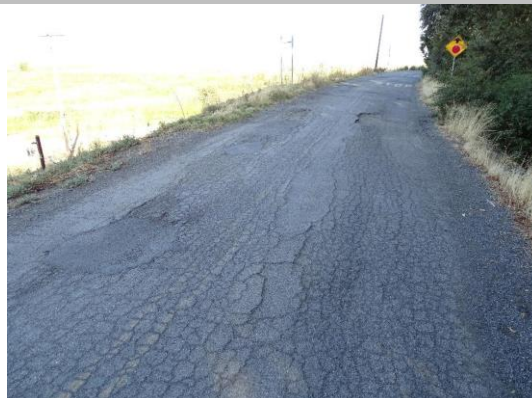
Photo 1 of 3 : UCIP_FA_2019_55791_82904.jpg

Comment Code						
Inspector Comment						
DS_ID:20224 FS_ID:55791 EP_NO: N/A Repair Type: Urgent Crossing Status: Found UCIP Comments: 09/30/2019 Erosion around headwall on WS progresses. Roger Cornwell who is a head of an irrigation district that operates the plant has been notified. Needs to run pumps to see if erosion is caused by leaking pipe(s). (O.Yakimov - DWR UCIP)03/12/2013 Headwall on WS undermined about 3-4-feet. FIELD_STRUCT_DESC: 1 of 3: 36-inch steel drainage pipe through the levee, 30.0 feet below the crown. Flap gate on the waterside (WS) end. 24-inch pipe sleeved through the 36-inch pipe. Annular space between pipes grouted. Pumps in pump house with walkway on landside (LS) toe. [Additional Reference(s): DWR Levee Log, 2006. USACE Sacramento O&M Manual 130, May 1960 (HLM 0.15)]. FS Date: 9/30/2019 7:39:29 AM

View of levee crown at the crossing

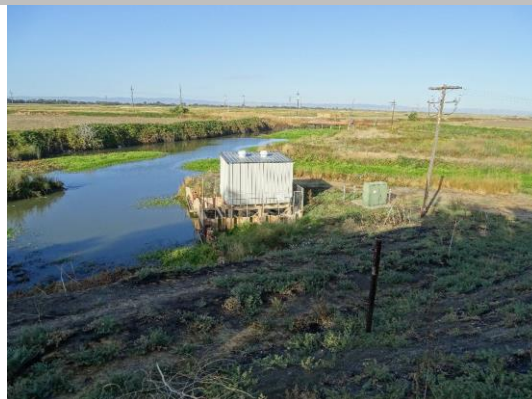
Photo 2 of 3 : UCIP_FA_2019_55791_82909.jpg

View of LS looking from levee crown

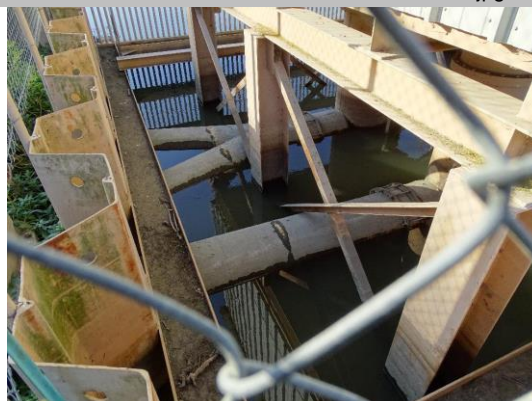
Photo 3 of 3 : UCIP_FA_2019_55791_82908.jpg

Comment Code					
Inspector Comment					
DS_ID:20224 FS_ID:55791 EP_NO: N/A Repair Type: Urgent Crossing Status: Found UCIP Comments: 09/30/2019 Erosion around headwall on WS progresses. Roger Cornwell who is a head of an irrigation district that operates the plant has been notified. Needs to run pumps to see if erosion is caused by leaking pipe(s). (O.Yakimov - DWR UCIP)03/12/2013 Headwall on WS undermined about 3-4-feet. FIELD_STRUCT_DESC: 1 of 3: 36-inch steel drainage pipe through the levee, 30.0 feet below the crown. Flap gate on the waterside (WS) end. 24-inch pipe sleeved through the 36-inch pipe. Annular space between pipes grouted. Pumps in pump house with walkway on landside (LS) toe. [Additional Reference(s): DWR Levee Log, 2006. USACE Sacramento O&M Manual 130, May 1960 (HLM 0.15)]. FS Date: 9/30/2019 7:39:29 AM

Pipe underneath pump house

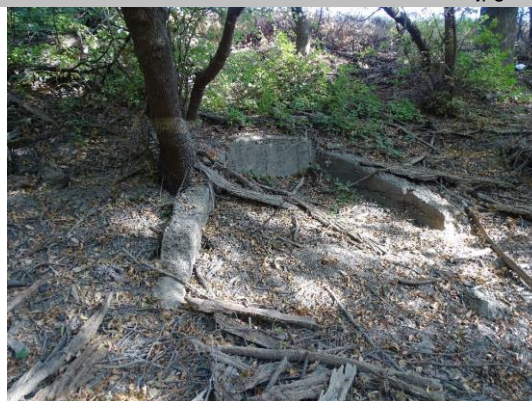
Photo 2 of 2 : UCIP_FA_2019_55794_82923.jpg

LM Start	0.22	Rating **	M	Issue No.	1555 (cont)	
LM End	0.22	Issue Type +	Ma	Location *		
Category	Supplemental			GPS Latitude/Longitude		
				Start	End	
Item	DRAFT DWR UCIP LMA Responsibility			38.802293 °	38.802293 °	
				-121.724847 °	-121.724847 °	
DWR ID	20327					
Comment Code						
Inspector Comment						
DS_ID:20327						
FS_ID:55794						
EP_NO: N/A						
Repair Type: Non-Urgent						
Crossing Status: Found						
UCIP Comments: 09/30/2019 Crossing looks abandoned (O.Yakimov - DWR UCIP)						
FIELD_STRUCT_DESC: *ABANDONED* 42-inch drainage pipe of an unknown material through the levee, 28.5 feet below the crown.						
Abandoned in place by plugging with concrete. Headwall on waterside (WS) toe. [Additional Reference(s): USACE Sacramento O&M Manual 130, May 1960 (HLM 0.22)].						
FS Date: 9/30/2019 9:45:45 AM

Concrete headwall and chute located at WS toe

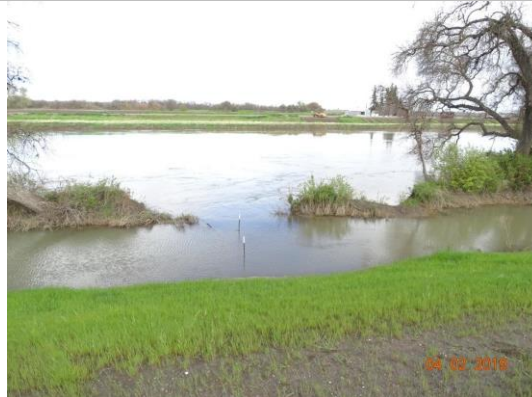
Photo 1 of 4 : FA_2019_NA0016_435_112_20190829_00043.jpg

LM Start	8.55	Rating **	A/W	Issue No.	112
LM End	8.55	Issue Type +	Ma	Location *	WS
Category	Earthen Levee			GPS Latitude/Longitude	
				Start	End
Item	Erosion / Bank Caving			38.857422 °	38.857422 °
				-121.780870 °	-121.780870 °
DWR ID	DWR_NA0016_01_s_2018_112				
Comment Code					
E1 : Note and monitor erosion site.					
Inspector Comment					
Location on waterside berm where oak tree fell and removed soil around the roots. Appears to be stable, but recommend monitoring.

View of erosion on the waterside berm. Spring 2019.

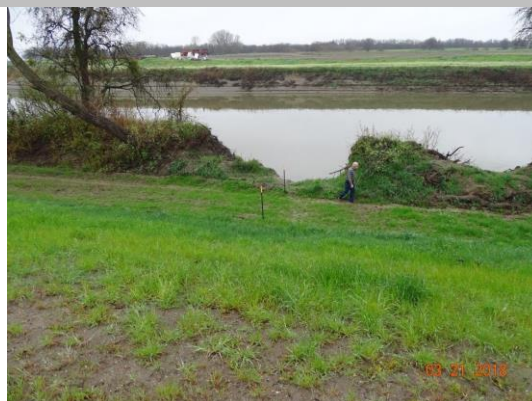
Photo 2 of 4 : FA_2019_NA0016_435_112_20190829_00044.jpg

LM Start	8.55	Rating **	A/W	Issue No.	112 (cont)	
LM End	8.55	Issue Type +	Ma	Location *	WS	
Category	Earthen Levee			GPS Latitude/Longitude		
				Start		End
Item	Erosion / Bank Caving			38.857422 °		38.857422 °
				-121.780870 °		-121.780870 °
DWR ID	DWR_NA0016_01_s_2018_112					
Comment Code						
E1 : Note and monitor erosion site.						
Inspector Comment						
Location on waterside berm where oak tree fell and removed soil around the roots. Appears to be stable, but recommend monitoring.

View of the berm where the oak tree used to stand, facing the Sacramento River. Spring 2018.

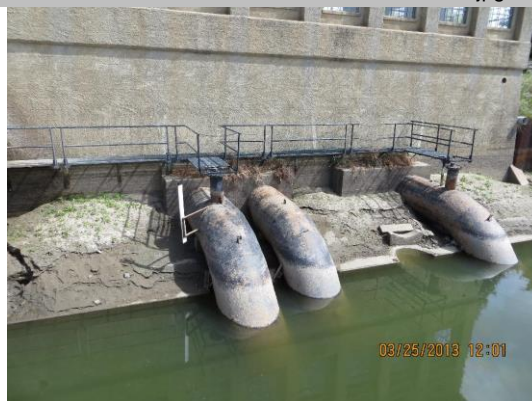
Photo 3 of 3 : UCIP_FA_2019_55838_17317.jpg

Pipe missing from intake structure on LS of pumphouse.

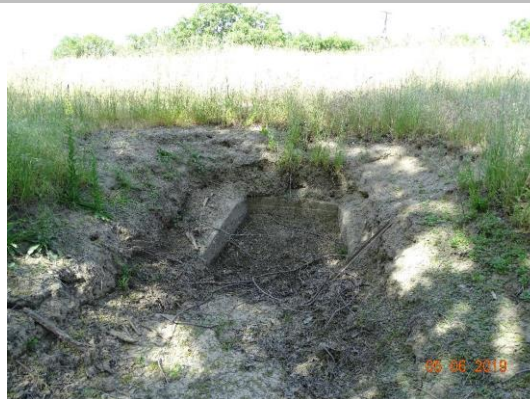
Photo 1 of 3 : UCIP_FA_2019_53982_79209.jpg

Slide gate silted on WS end

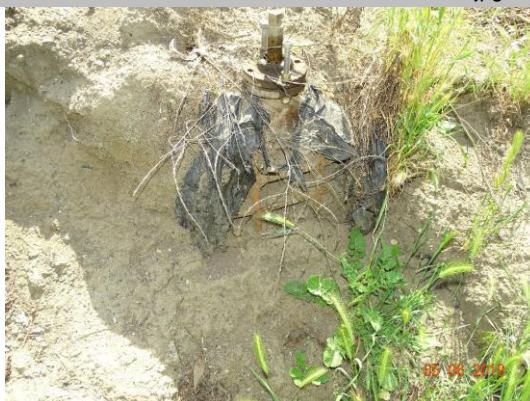
Photo 2 of 3 : UCIP_FA_2019_53982_79210.jpg

Gate valve silted at LS toe. Missing handwheel

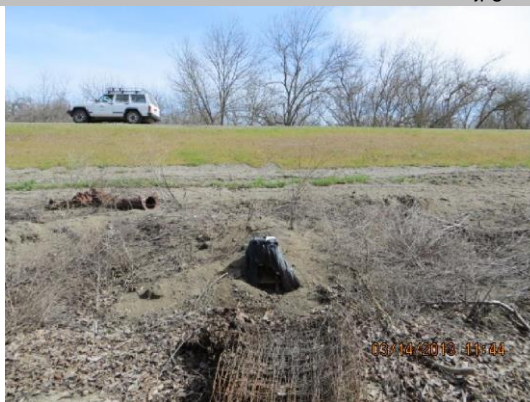
Photo 3 of 3 : UCIP_FA_2019_53982_17548.jpg

Gate valve buried on LS toe

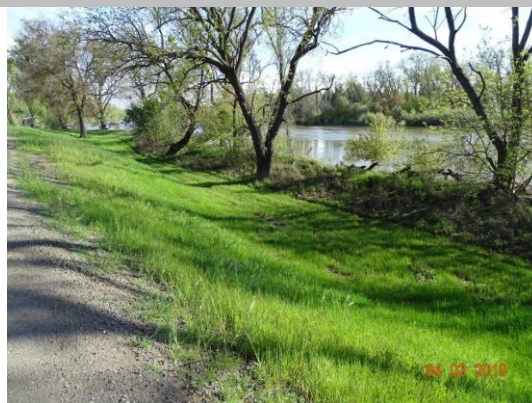
Photo 5 of 5 : FA_2019_NA0016_435_114_20190829_00052.jpg

View of the erosion site from the crown, facing upstream. Spring 2019.

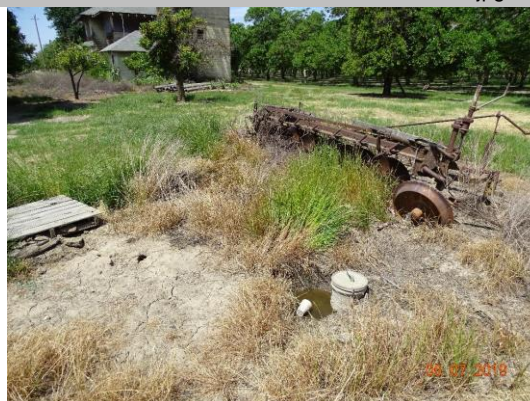
Photo 3 of 3 : UCIP_FA_2019_54164_79777.jpg

Water leaks around capped pipe on LS

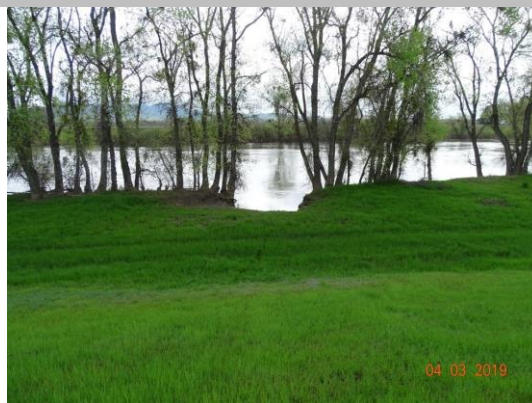
Photo 1 of 1 : FA_2019_NA0016_435_119_20190829_00053.jpg

View of erosion from the crown. Spring 2019.

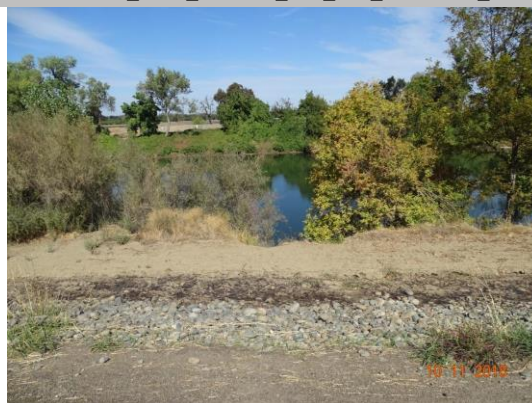
Photo 1 of 1 : FA_2019_NA0016_435_113_20190829_00047.jpg

View of erosion on the waterside berm. Fall 2018.
